Transport
Canada

Issue 4/2011

Canadian Aviation Service Difficulty Reports

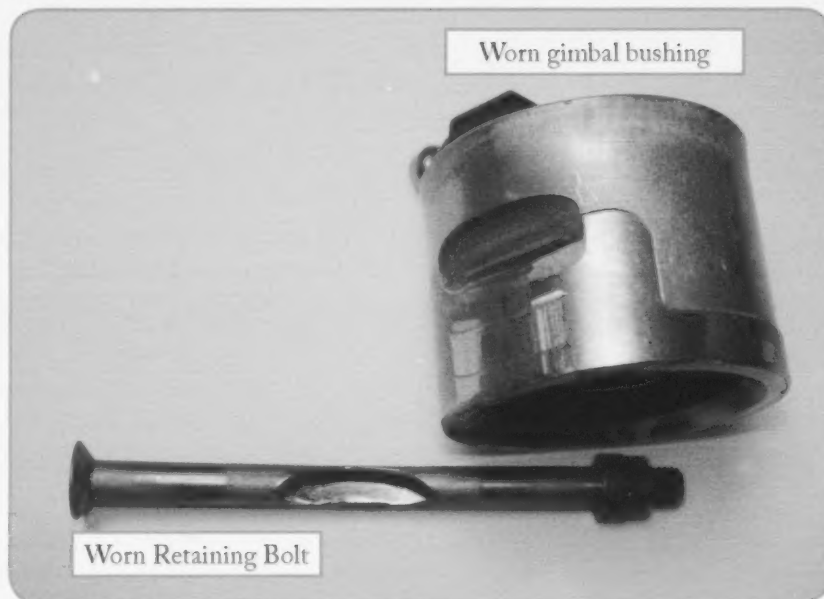
Flap Gimbal Bushing Excessive Wear

During a scheduled performance of Boeing task cards 27-144-00-01/02 to lubricate the left and right inboard flap outboard ballscrew and gimbals, it was found that the lower gimbal bushing assembly on both the left and the right inboard flaps had migrated out from their respective gimbal seats.

The results of these migrated bushings were excessively worn attachment bolts, which are used to retain the bushings within the gimbal.

The photo to the right shows the abnormal wear of a retaining bolt and gimbal bushing. Both gimbal bushing assemblies and retaining bolts were replaced and the aeroplane was released back to service.

Boeing Fleet Team Digest (FTD) 737NG-FTD-27-03006 defines in detail this possible scenario which is rooted to the application of excessive high grease-gun pressures that can apply undue pressure on the gimbal bushing, forcing it to migrate out and wear into its retaining bolt.

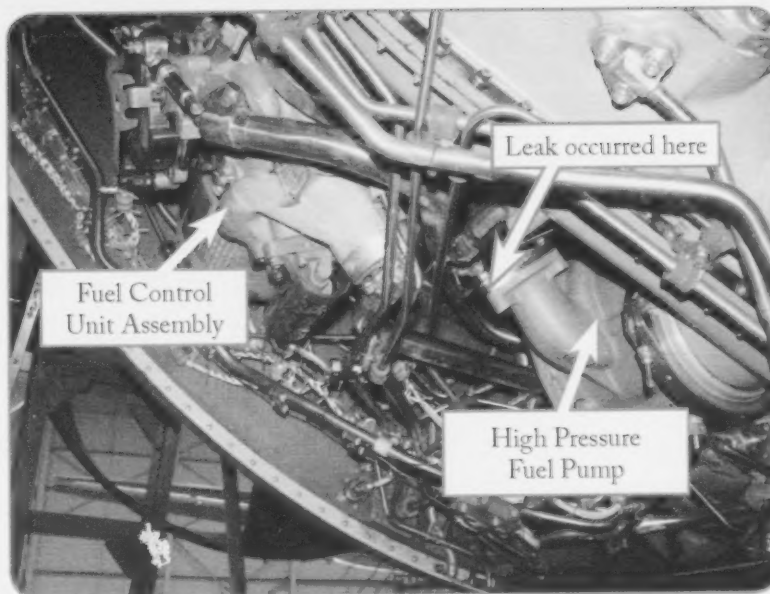
Engine Fuel Leak and Imbalance

During cruise, the aeroplane experienced a large fuel imbalance due to a fuel leak at the right hand engine. The aeroplane declared an emergency and diverted where upon arrival the right hand tank fuel quantity was 1500 kilogram (kg) less than the left hand tank.

Maintenance personnel found an o-ring that was leaking at the right engine high-pressure fuel pump feed line. The o-ring was replaced and the aeroplane was returned to service.

The reason behind the failure of the o-ring has not been determined but is suspected that possible damage or improper installation of the new o-ring was incurred during the pumps replacement.

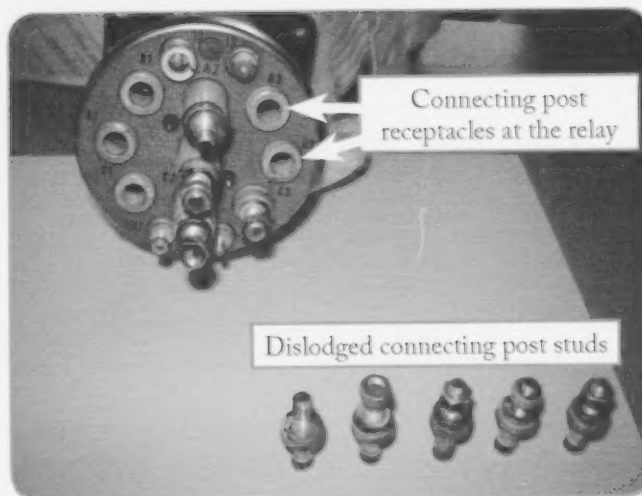
Relay Failure

During flight, several system failure messages were posted where maintenance troubleshooted the fault to a failing relay.

It was noted that several of the connecting post studs were loose within the relay body receptacles, breaking the posts electrical continuity capability.

The relay was replaced and the aeroplane was made serviceable.

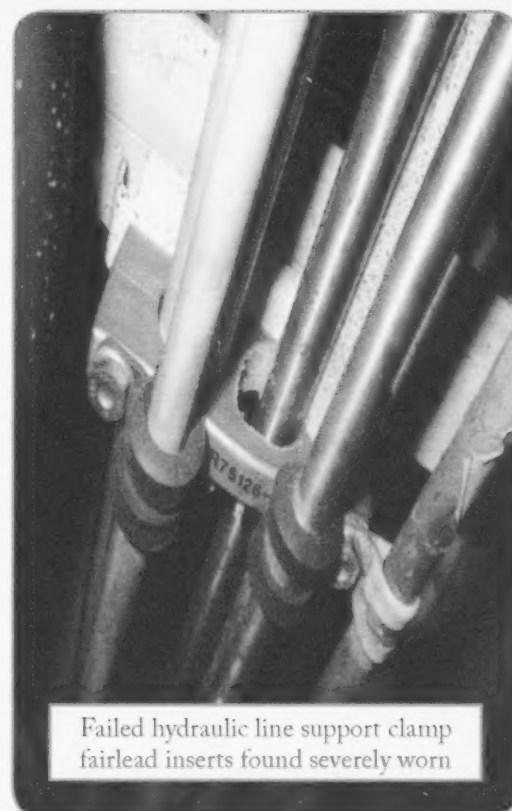
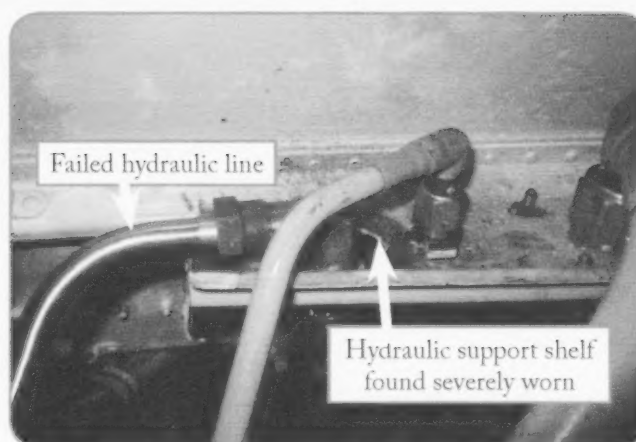
Insufficient Hydraulic Line Support

Upon maintenance investigation, it was found that the #1 hydraulic pressure line in the aft equipment bay was chaffed through, causing the complete loss of the fluid. The chaffing was a result of the hydraulic line jam-nuts at the top of the hydraulic support shelf coming loose, allowing significant movement and vibration.

The hydraulic support shelf was severely worn along with several support bracket fairleads downstream the line.

This scenario demonstrates that the worn fairlead inserts were an indicator of a more significant failure elsewhere in the system.

The hydraulic support shelf was repaired, the hydraulic line and fairlead inserts for the support brackets were replaced and the aircraft was made serviceable.

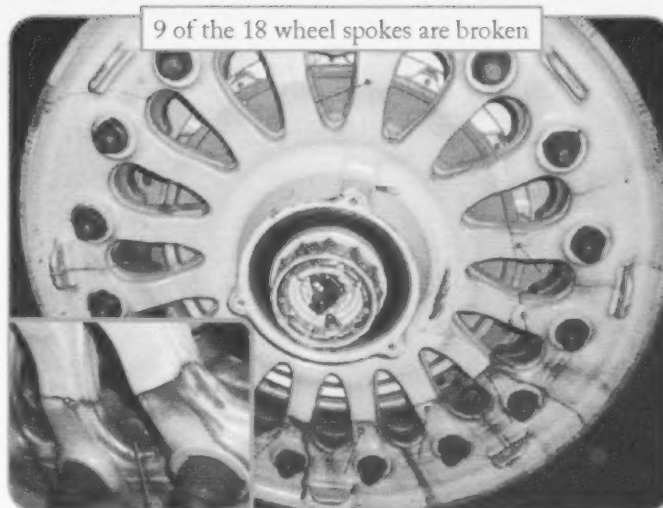
Main Landing Gear Wheel Rim Cracks

During a standard service check it was found that several rim spokes of the main landing gear wheel number 2 (left-hand inboard) were found cracked.

The wheel assembly was replaced as per the aircraft maintenance manual and the aeroplane was made serviceable.

The close visual inspection of all wheel assembly landing gear items is an essential task to accomplish for all pre-departure walk-around and service checks. ✖

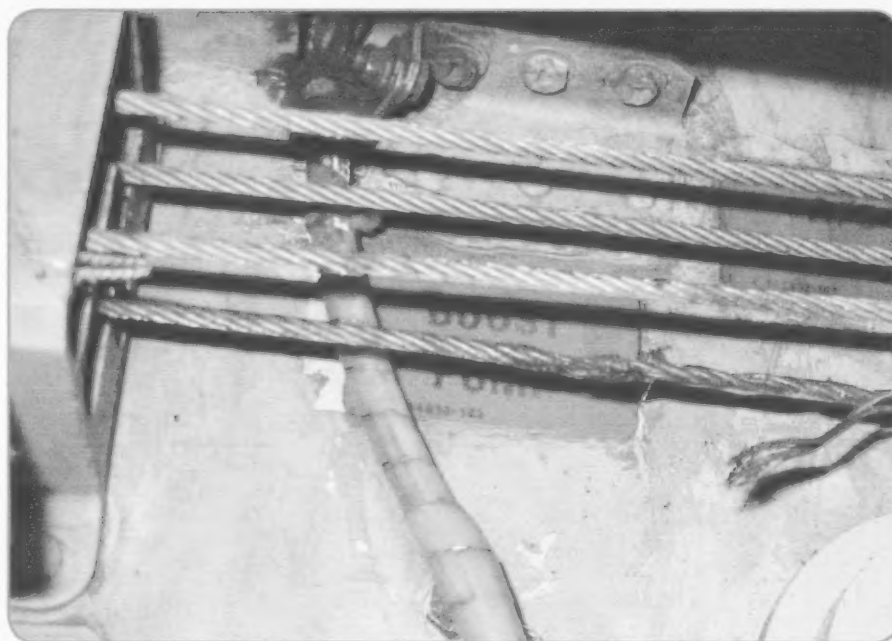
Frayed Aileron Cable

During inspection, the right-hand aileron cable was found to be significantly frayed and beginning to unravel. The area of the failing cable (Wing Station (WS) 181) is located in a cable block on the aft spar where aluminum guide rollers part number FL4C6-2. This particular area of the cable is almost impossible to see when the gust lock is engaged and/or the aileron is in a neutral position because of the cable block.

A reminder for personnel that during flight control cable inspection that the entire cable run must be inspected to detect these types of failures. ✖

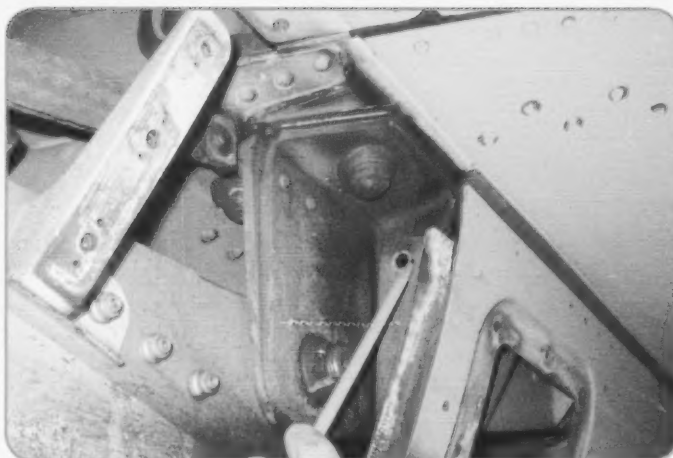
Pylon Fairing Missing Attaching Hardware

During a heavy maintenance "N1" check visit on the aeroplane, a left-hand pylon inspection found that the aft lower fixed fairing assembly was missing several items of attaching hardware. Within the pylon fixed fairing, both forward quick release pins had fallen out, as had one of four mid-point attach bolts. The missing hardware was found in the bottom of the fairing. The right-hand pylon was found to have the two forward quick release pins and three of four mid-point bolts also missing. The pins and two of the three missing bolts were found inside the fairing. In both cases, the four aft mounting bolts were found installed and properly torqued.

This operator obtained the required engineering Original Equipment Manufacturer (OEM) and company approval to install a single dash length longer attaching bolt and reinstalled new quick release "pip" pins.

Transport Canada Civil Aviation (TCCA) would like to advise all Embraer 170 operators of this Service Newsletter (SNL) and its intent to replace the discrepant hardware to increase its bolt length, final torque and to introduce a new countersunk washer. ✖

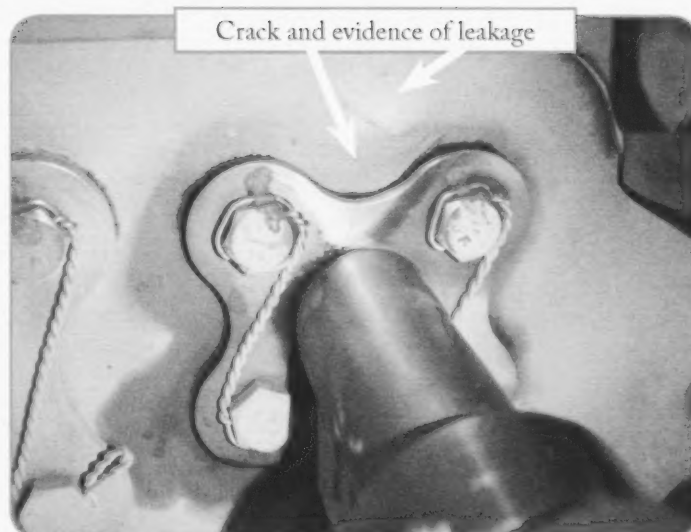
Engine Driven Pump Hydraulic T-Fitting Cracks

During a heavy maintenance "C-check" visit, maintenance found the #1 & #2 pylon engine driven hydraulic pump pressure line T-fittings cracked and with evidence of hydraulic fluid leakage.

Both pressure line T-fittings were replaced to correct the fault.

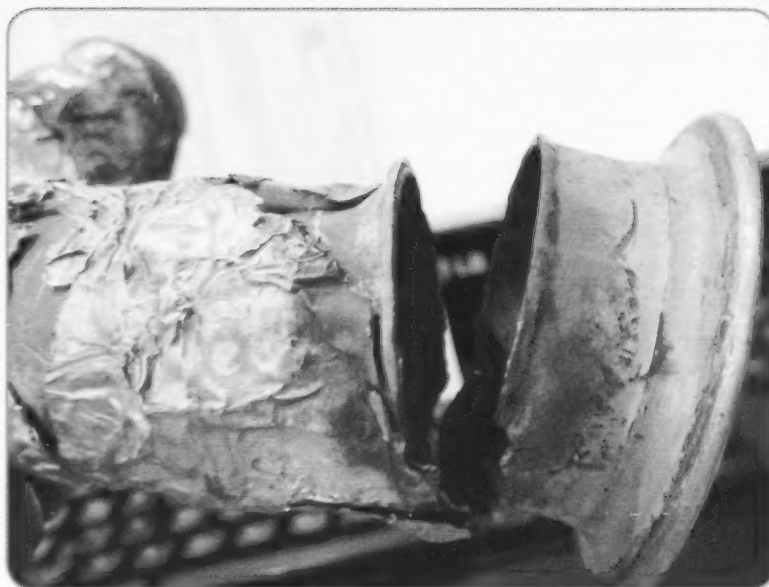
Metroliner Bleed Duct Failure

The pressurization was snagged as inoperative by the flight crew. During maintenance trouble-shooting it was noted that the engine bleed pressure would fluctuate uncontrollably and when turned to "high" only function for approximately 30 seconds. Then the eyeball vents would drop off with almost no air-flow output available.

During subsequent inspection of the right-hand wing bleed air duct plumbing, maintenance found the tube assembly from the right-hand modulating valve to right-hand cooling turbine cracked in half. The tube was replaced, ground run accomplished and the aircraft returned to service.

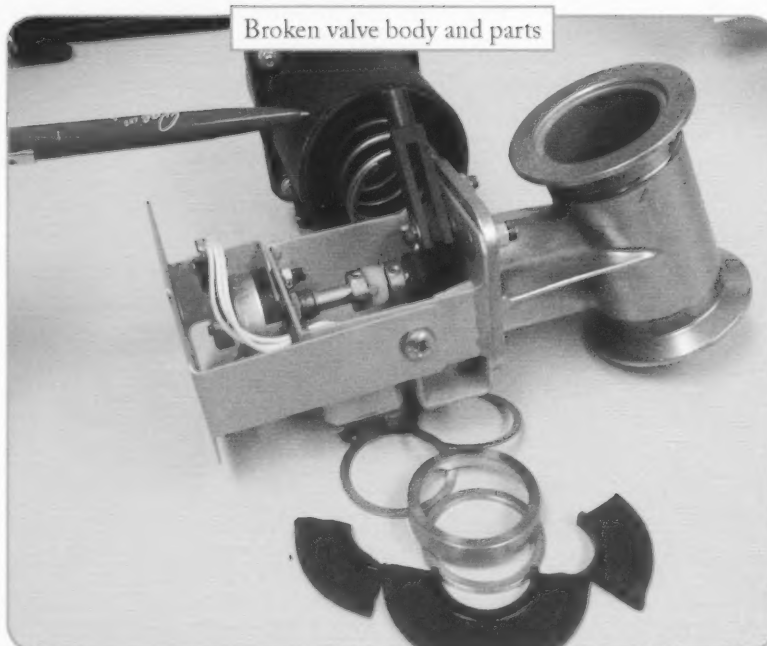
Cabin Temperature Control Valve Failure

During cruise, the cabin temperature was uncontrollable, leaving the cabin in a very warm and uncomfortable condition.

Upon maintenance investigation, the cabin temperature control valve plunger body was found cracked off, shearing the plastic link arm which opens and closes the butterfly valve and rendering it uncontrollable.

The valve was replaced and the aircraft made serviceable.

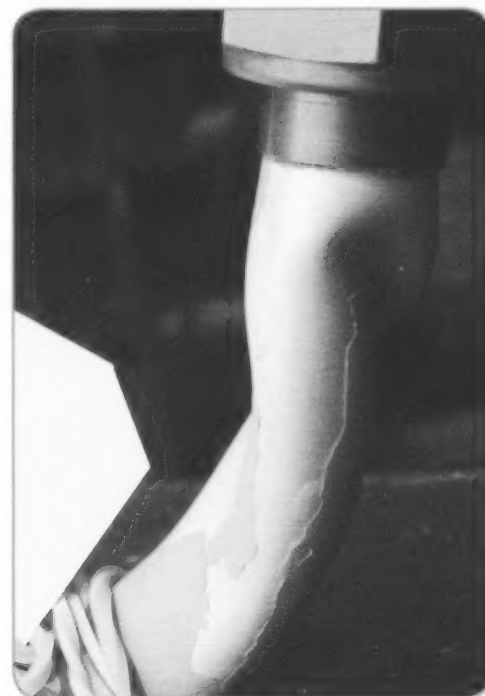
During a scheduled inspection on a SAAB 340A, maintenance found a fuel line twisted on the left-hand engine lower nacelle.

The line was removed, replaced and the aeroplane was made serviceable.

When installing fuel lines of any type and in particular aluminum, proper aircraft maintenance manual torque values must be followed. ✖

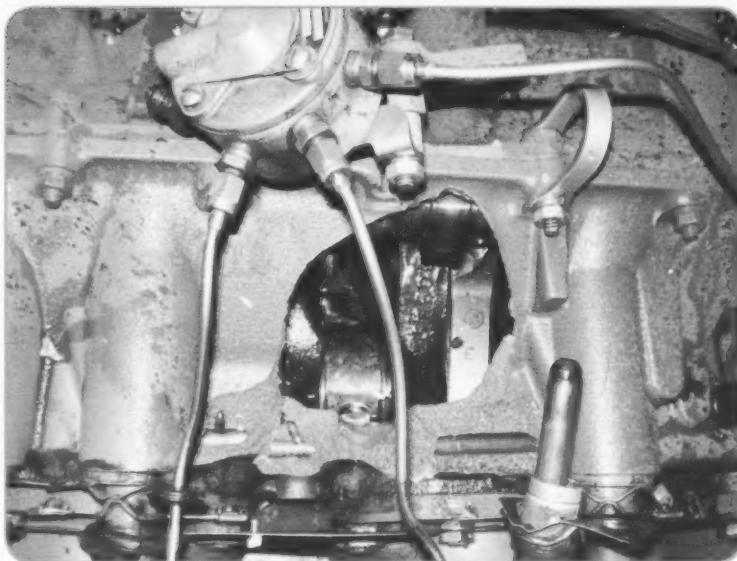
Connecting Rod Failure

The pilot reported a loud bang and subsequent engine failure. The pilot auto-rotated to an open field with no damage to the airframe during the landing. The aeroplane was removed from the field and transported to a repair facility for further investigation. Aeroplane panels were removed and a large hole in the crankcase was observed near the #3 cylinder intake lifter bore. Large pieces of crankcase debris were found on top of the engine case above the #2 cylinder area. Lycoming was advised and a field service rep came to investigate the failure on location.

Initial indications were the #4 connecting rod failed just below the piston pin area and this caused the breach in the crankcase between the #3 & #4 cylinders.

The cause of this connecting rod failure was the result of a missing wrist Pin Plug. Maintainers are reminded that all manufacturers' instructions must be followed. ✱

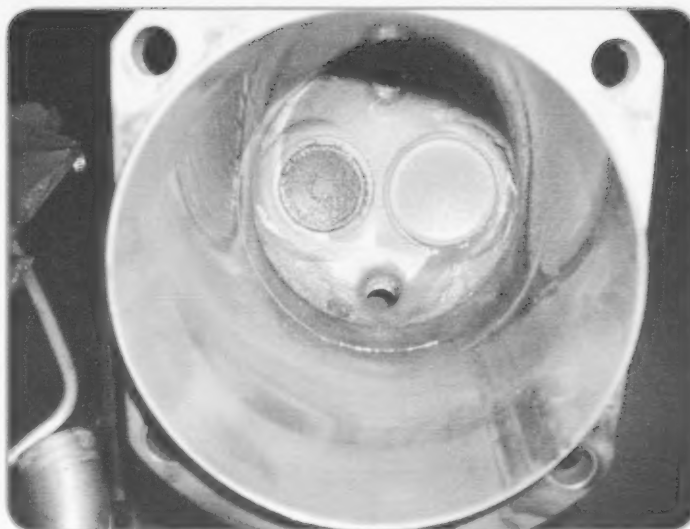
Sudden Engine Stoppage

The engine experienced a sudden stoppage in flight. Aircraft was landed and the engine was removed and shipped for inspection. Upon disassembly, it was found that the #4 cylinder failed due to a crack that progressed from near the top of the barrel almost all the way around the circumference. This failure seized the engine. This cylinder appears to be a field overhauled unit and has been sent to Transport Safety Board (TSB) for inspection. The last engine logbook entry has 488.9 hours since overhaul. The engine was last overhauled June 19, 2009 and was installed October 23, 2009.

It is likely that this crack was almost undetectable using visual inspection technique before the catastrophic failure. Field overhauls must be completed in accordance with the manufacturer's instruction and include any required Non-Destructive inspections carried out by an appropriately rated facility. ✖

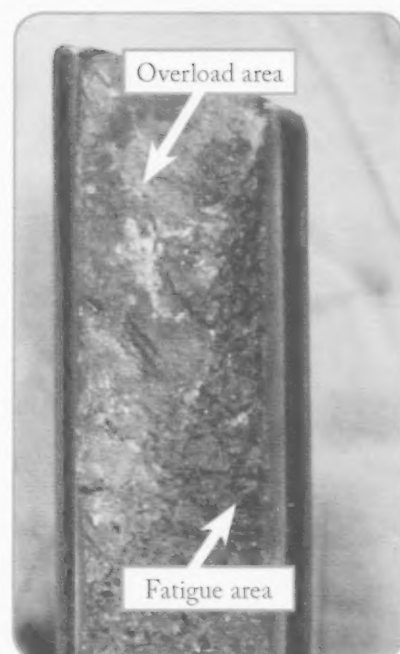
Power Turbine Failure

The engine was removed subsequent to a catastrophic failure during takeoff role. The pilot reported, "engine failed on takeoff roll, audible noise, metal exiting exhaust duct, engine went to minimum flow and takeoff aborted".

During a dismantle investigation, the power section was found excessively damaged and it appeared that the failure occurred in the power turbine area. The 1st stage power turbine blades were found broken close to the platform areas. The fracture surface exhibited rough appearance with textures of brittle overloading fracture. The 2nd stage power turbine blades were found broken; the breakage varying from below shrouded the blade tip to above the blade platform.

Service Bulletin (SB) 14369 was released to address a premature failure issue and Service Bulletin (SB) 14003 provides relevant life limit recommendations for pre-service bulletin 14369 2nd stage power turbine blades. ✖
